The Road Inventory of Las Vegas National Wildlife Refuge

Las Vegas, NM

Prepared By:
Federal Highway Administration
Central Federal Lands Highway Division
December 2009

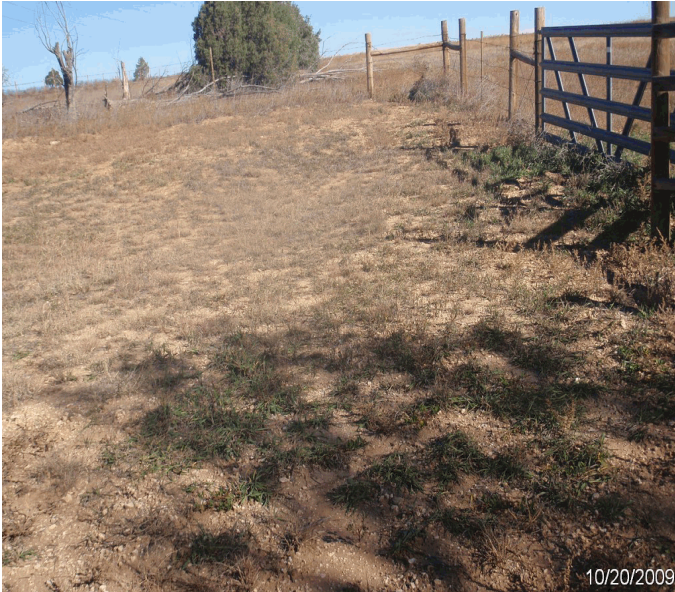
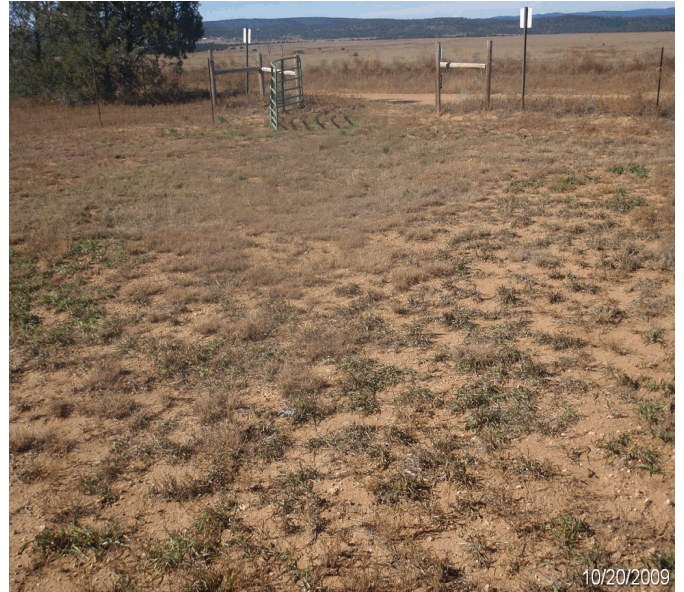
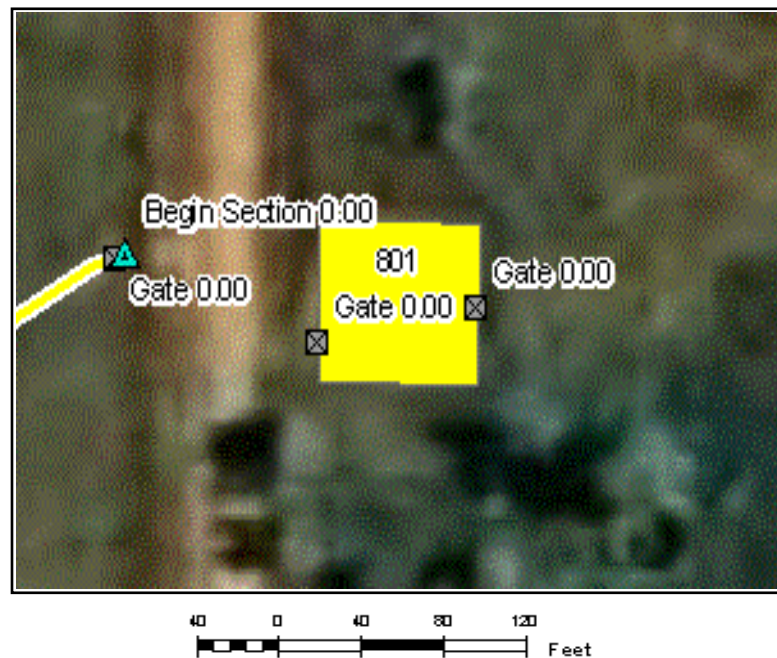
801: RU 8 Hunter Parking

Asset Number	Date Visited	Surface Type	Area (Sq Ft)	Condition	Cost to Improve
	10/20/2009	Native	3,198	Fair	900

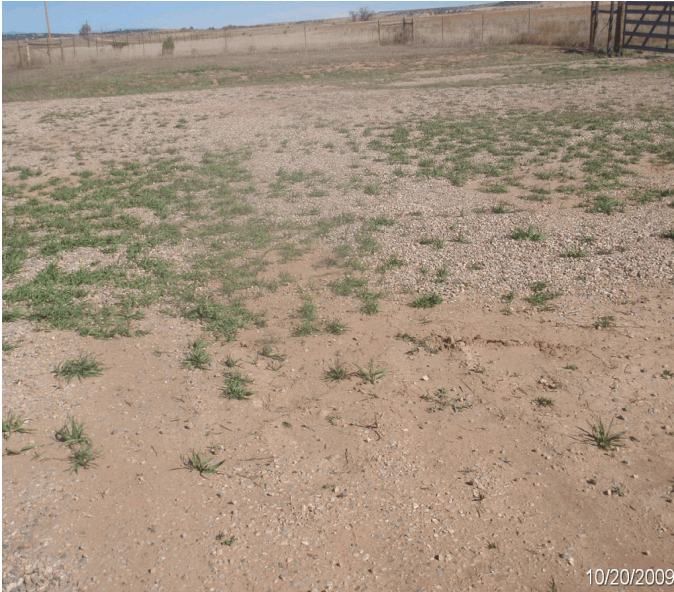
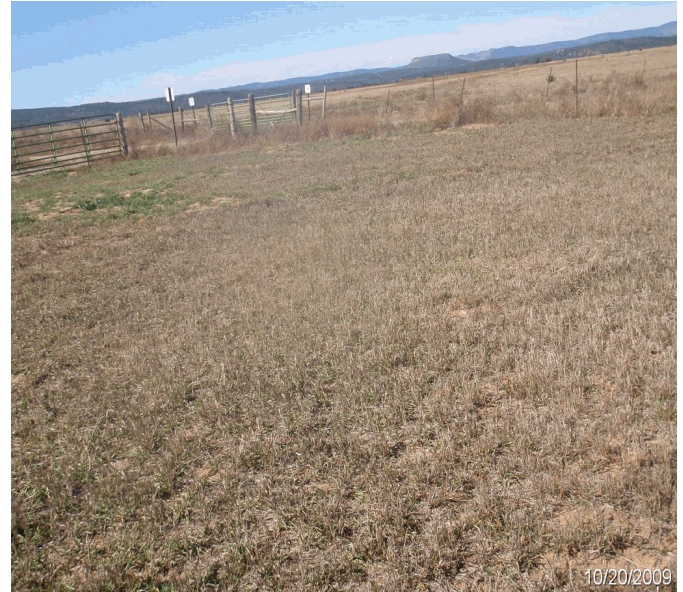
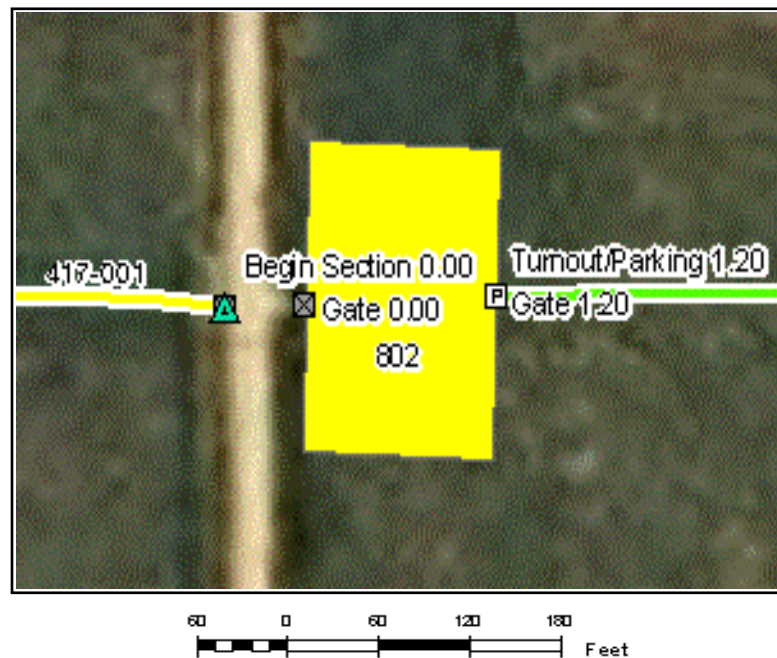
802: Middle Marsh Road Hunter/RU 8 Parking

Asset Number	Date Visited	Surface Type	Area (Sq Ft)	Condition	Cost to Improve
	10/20/2009	Gravel	13,406	Fair	3,600

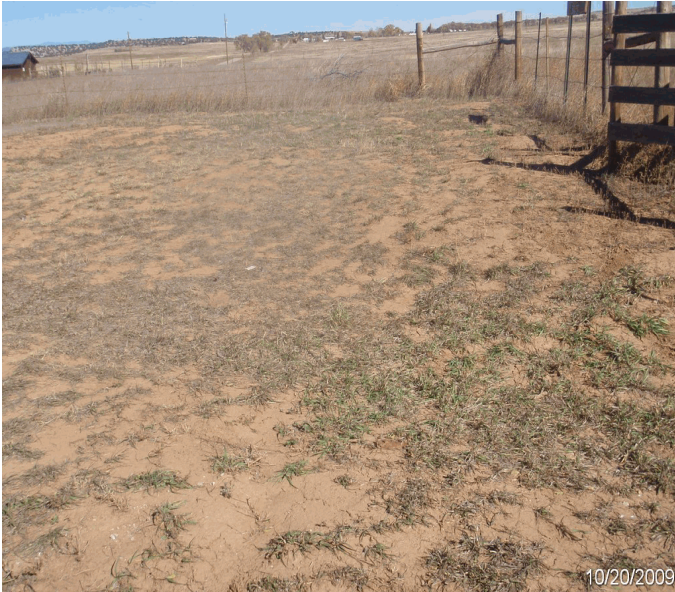
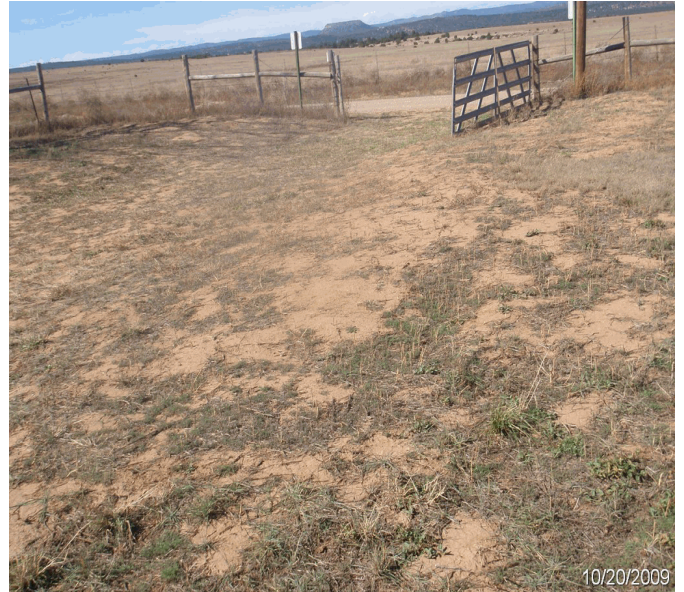
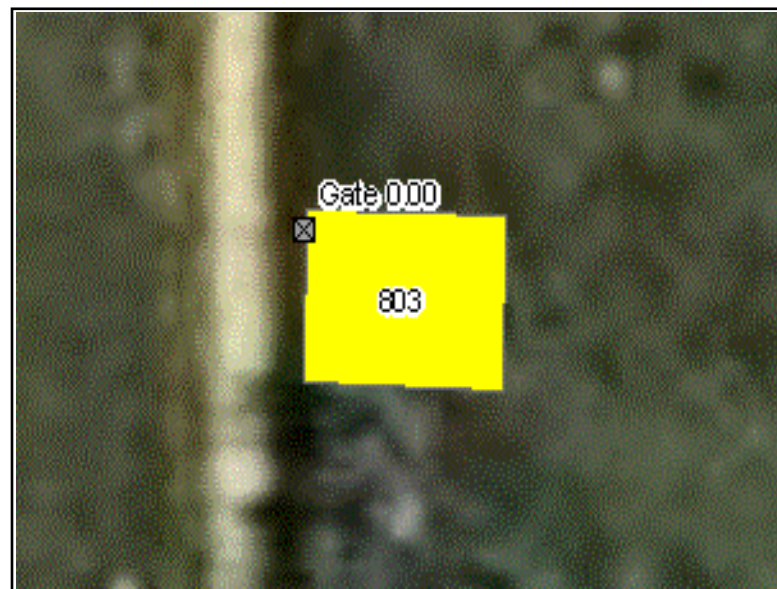
803: RU 8 North Parking

Asset Number	Date Visited	Surface Type	Area (Sq Ft)	Condition	Cost to Improve
	10/20/2009	Native	3,928	Fair	1,000

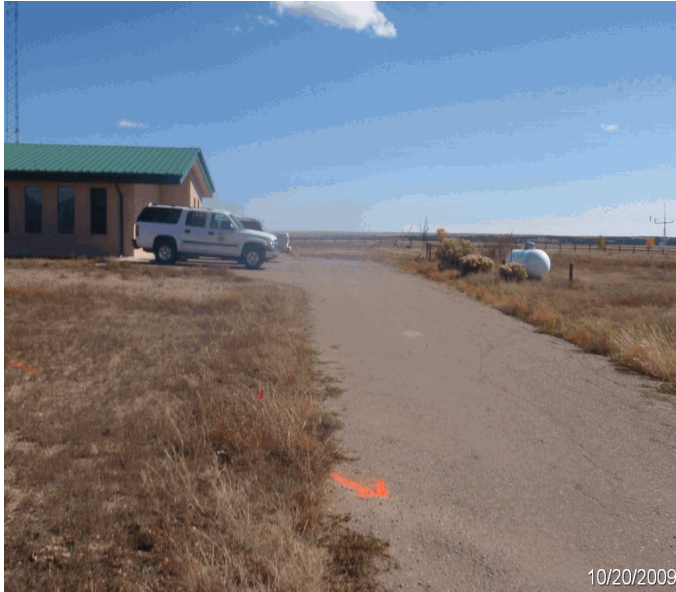
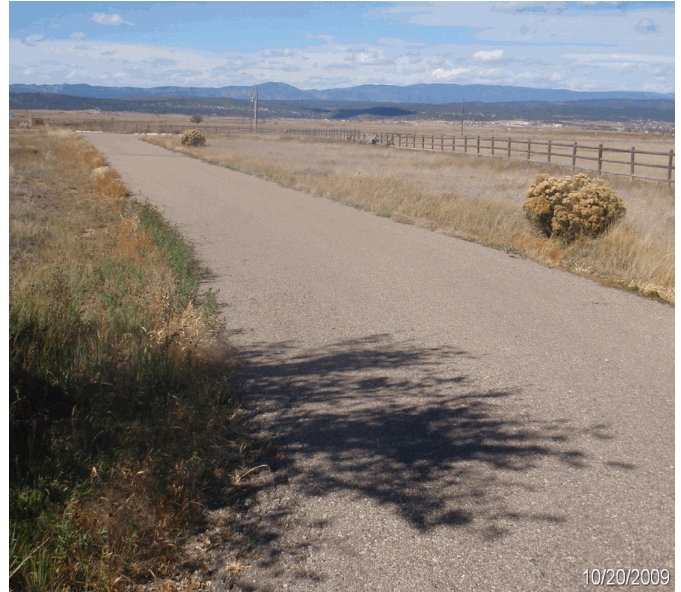
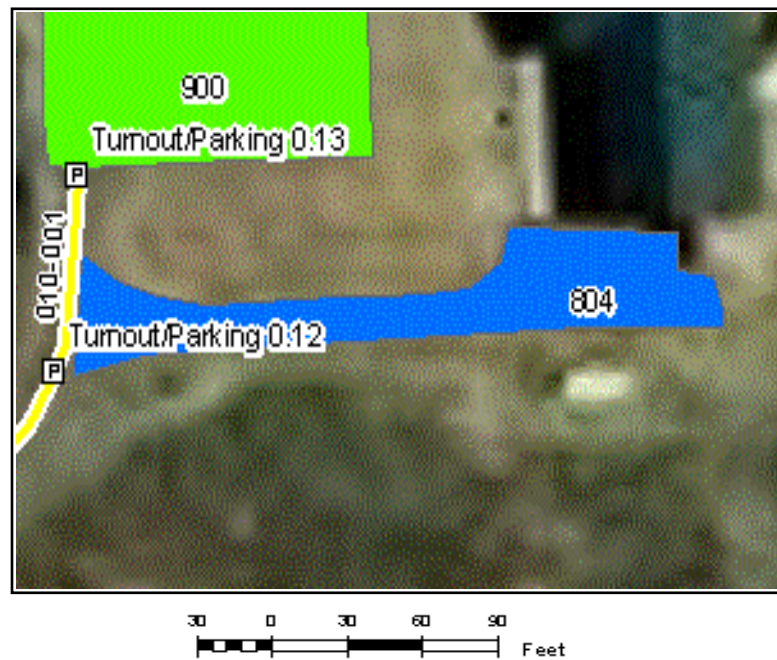
804: Headquarters Employee Parking

Asset Number	Date Visited	Surface Type	Area (Sq Ft)	Condition	Cost to Improve
	10/20/2009	Asphalt	3,611	Excellent	0

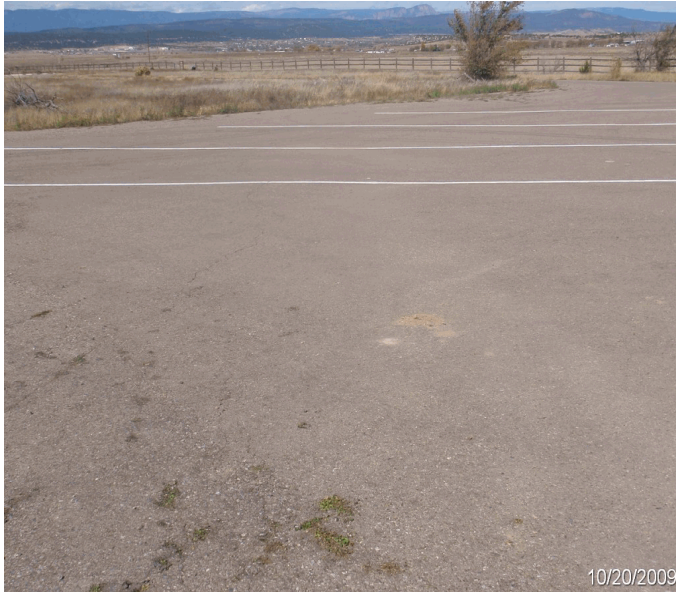
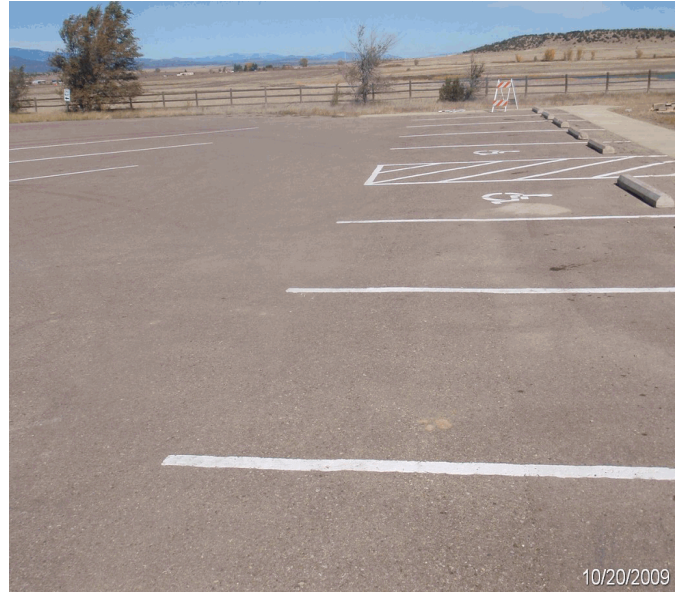
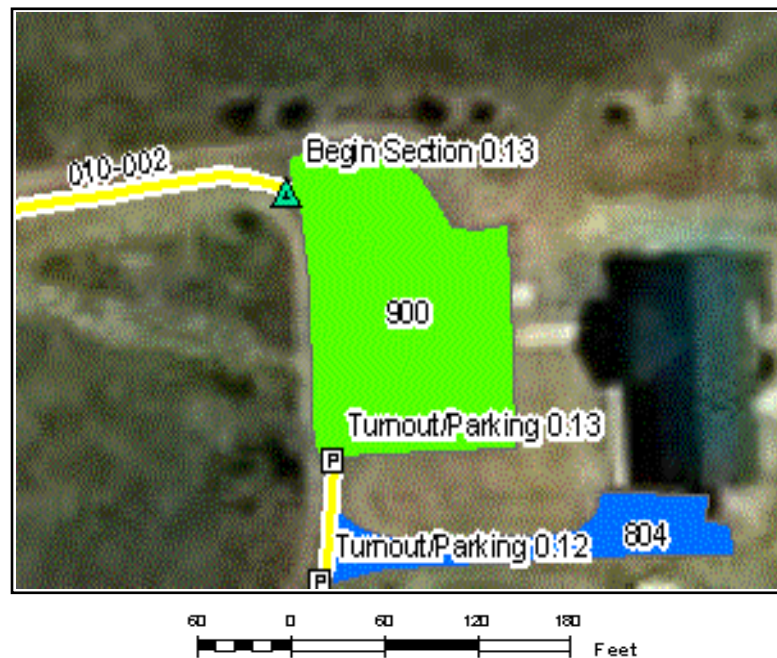
900: Visitor Center Parking

Asset Number	Date Visited	Surface Type	Area (Sq Ft)	Condition	Cost to Improve
10059269	10/20/2009	Asphalt	12,075	Good	2,300

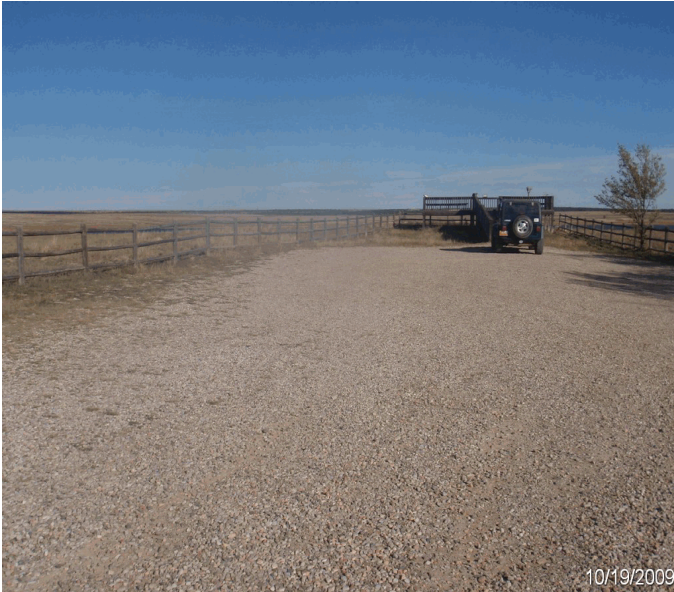
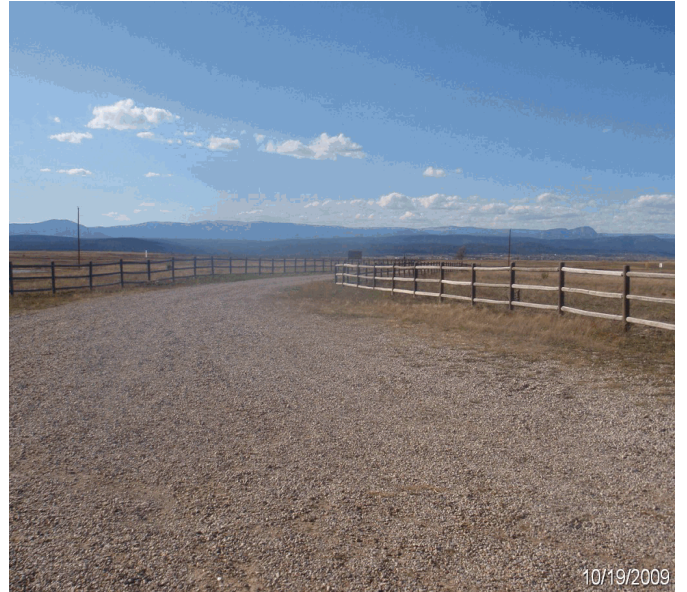
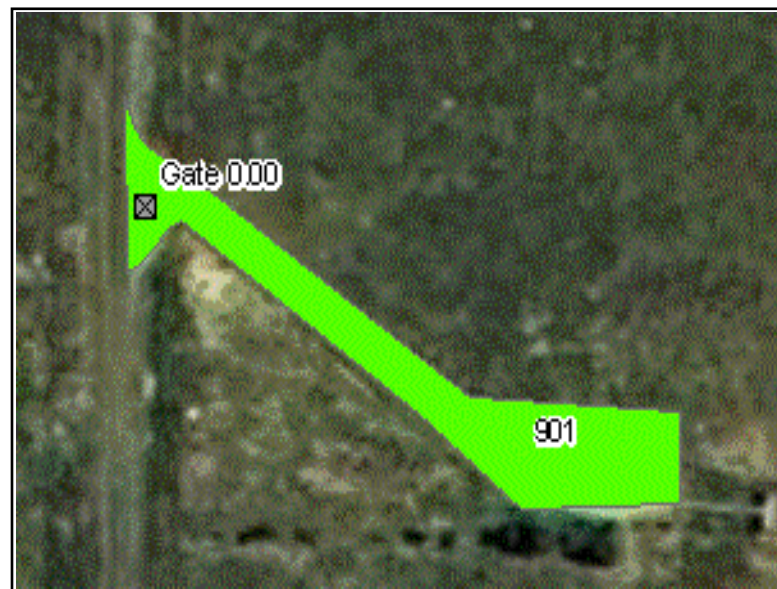
901: Crane Overlook Parking Area

Asset Number	Date Visited	Surface Type	Area (Sq Ft)	Condition	Cost to Improve
10059273	10/19/2009	Gravel	23,809	Good	3,600

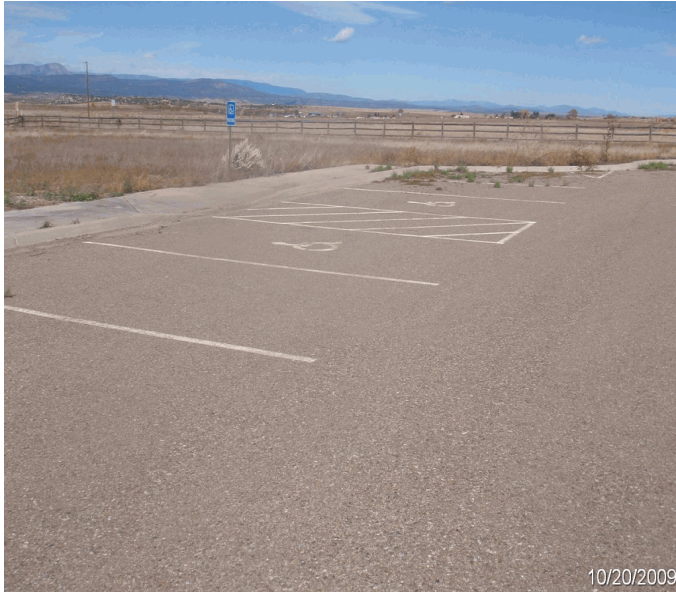
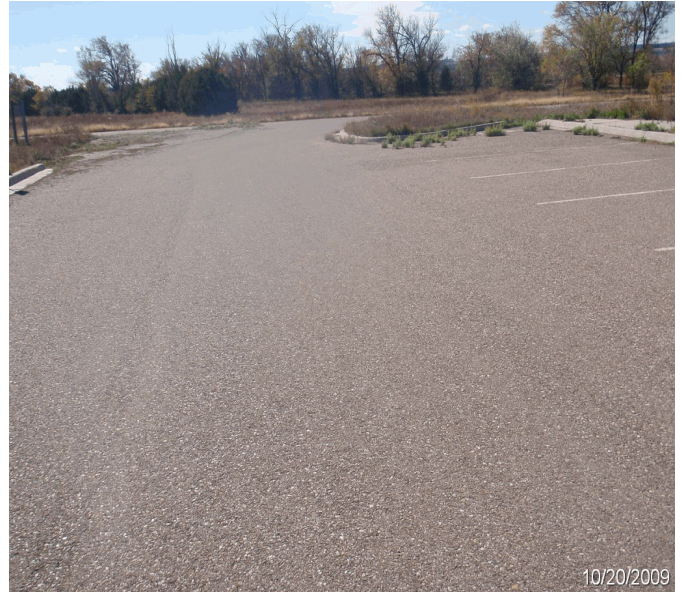
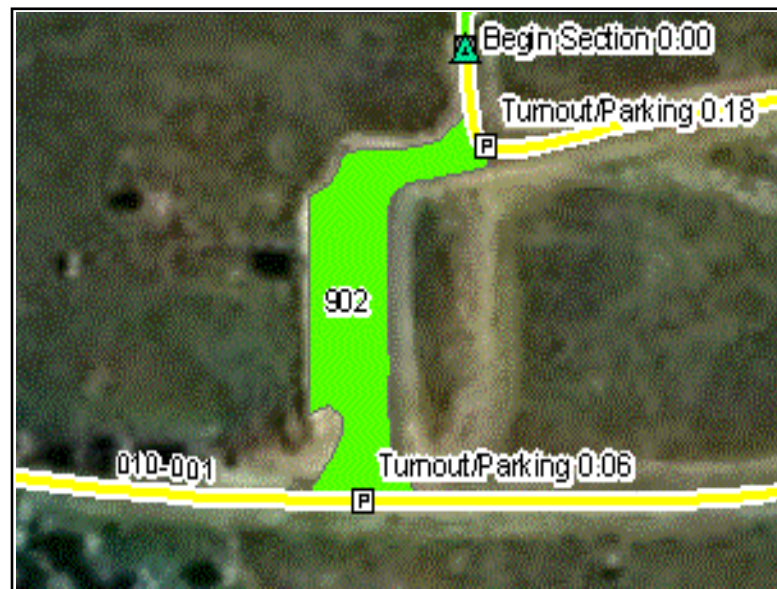
902: Visitor Center Overflow Parking

Asset Number	Date Visited	Surface Type	Area (Sq Ft)	Condition	Cost to Improve
10059269	10/20/2009	Asphalt	11,409	Good	2,100
